STS-107 *Columbia* Reconstruction Report

STS-107 Columbia Reconstruction Report

NSTS-60501

JUNE 30, 2003

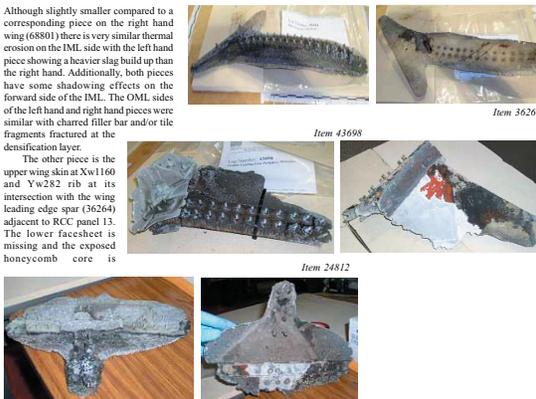
The other piece is the upper wing skin at Xw1160 and Yw282 rib at its intersection with the wing leading edge spar (36264) adjacent to RCC panel 13. The lower facesheet is missing and the exposed honeycomb core is

thermally eroded down to the potting adhesive used around the string of fasteners where the rib attached on the IML side.

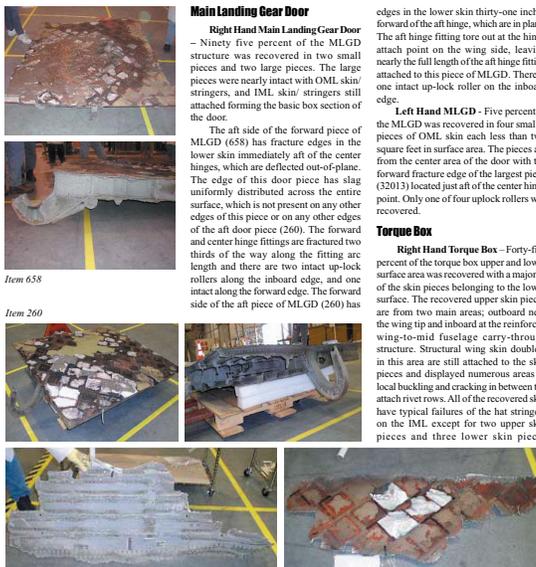
The aft side of the forward piece of MLGD (658) has fracture edges in the lower skin immediately aft of the center hinges, which are deflected out-of-plane. The edge of this door piece has slag uniformly distributed across the entire surface, which is not present on any other edges of this piece or on any other edges of the aft door piece (260). The forward and center hinge fittings are fractured two thirds of the way along the fitting arc length and there are two intact up-lock rollers along the inboard edge, and one intact along the forward edge. The forward side of the aft piece of MLGD (260) has

edges in the lower skin thirty-one inches forward of the aft hinge, which are in plane. The aft hinge fitting tore out at the hinge attach point on the wing side, leaving nearly the full length of the aft hinge fitting attached to this piece of MLGD. There is one intact up-lock roller on the inboard edge.

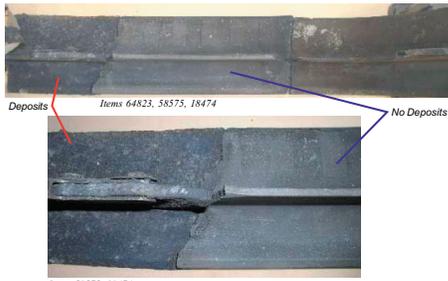
spar, with the aluminum access panel providing a secondary source. The highest concentration of deposits on the panels is the lower portion of right hand RCC panel 2, which coincides with a missing lower access panel 2. Fracture sequencing can be determined based on deposit levels. Panel 2 and its associated gap seal have a heavy concentration of metallic deposits on one side of a fracture while the mating fracture surface is completely free of deposits. This condition is found on the gap seal (64823, 58575, 18474) where the middle

Deposits Items 64823, 58575, 18474 No Deposits Items 58575, 18474

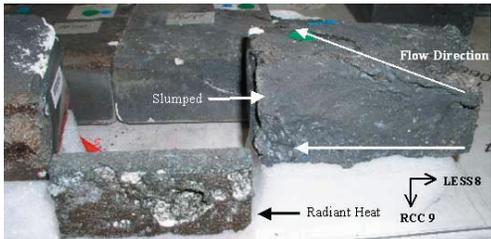
Flow Direction Slumped Radiant Heat LESS 8 RCC 9

The slumping and erosion of the tiles for panel 9 originates in the inboard forward corner, which aligns directly with the design notch in the heel of RCC panel 8 as shown above. There are ten spar fittings per side, five upper and five lower. Six of ten right hand fittings were recovered, upper 8, 9 and lower 8, 9, 10 and 11. The right hand fittings have minor splattering of metallic deposits. No left hand spar fittings were recovered for rib splice 8 through 10 and only portions of the fittings for rib splice 11 and upper 12 were recovered. Nine of the ten spanner beams on the right hand side were recovered, six of which are complete assemblies. Only portions of three spanner beams were recovered for the left hand side, none in panels 8, 9 or 10. Spar-side thermal erosion occurred on several of the recovered spanner beams as shown below:

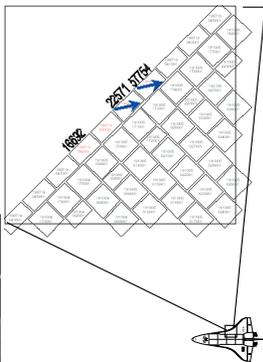
Figure 9.2. Reconstruction of recovered left hand lower LESS Carrier Panel 9 tiles.

- Tile slumping and surface deposits on the left lower LESS carrier panel tiles are consistent with flow occurring from inside the RCC cavity out through the upper and lower carrier panel locations in that vicinity
- The surface deposits on lower left hand carrier panel 9 tiles are consistent with a flow direction exiting from RCC panel 8.
- The thermal degradation of the internal tiles recovered from upper carrier panel

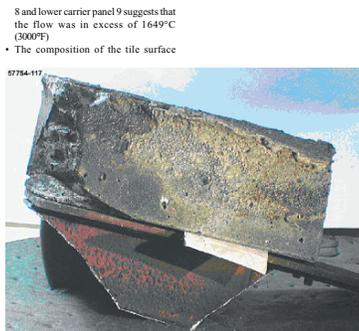
Figure 9.7. Tile Item 57754 bonded to section of carrier panel

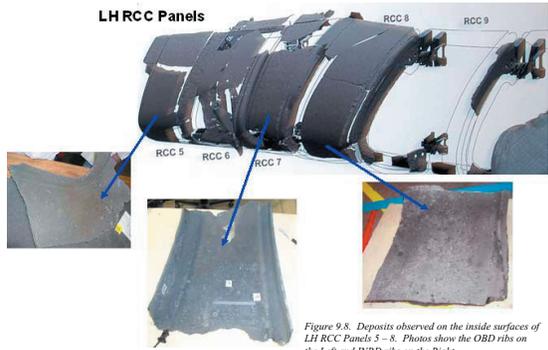
Figure 9.8. Deposits observed on the inside surfaces of LH RCC Panels 5 - 8. Photos show the OBD ribs on the Left and INBD ribs on the Right.

deposits suggests that the flow contained molten/vaporized materials from the LESS internal insulators, attachments, carrier panels, and/or wing spar.
